KØGE BAY (DENMARK)

1. GENERAL DESCRIPTION OF THE AREA

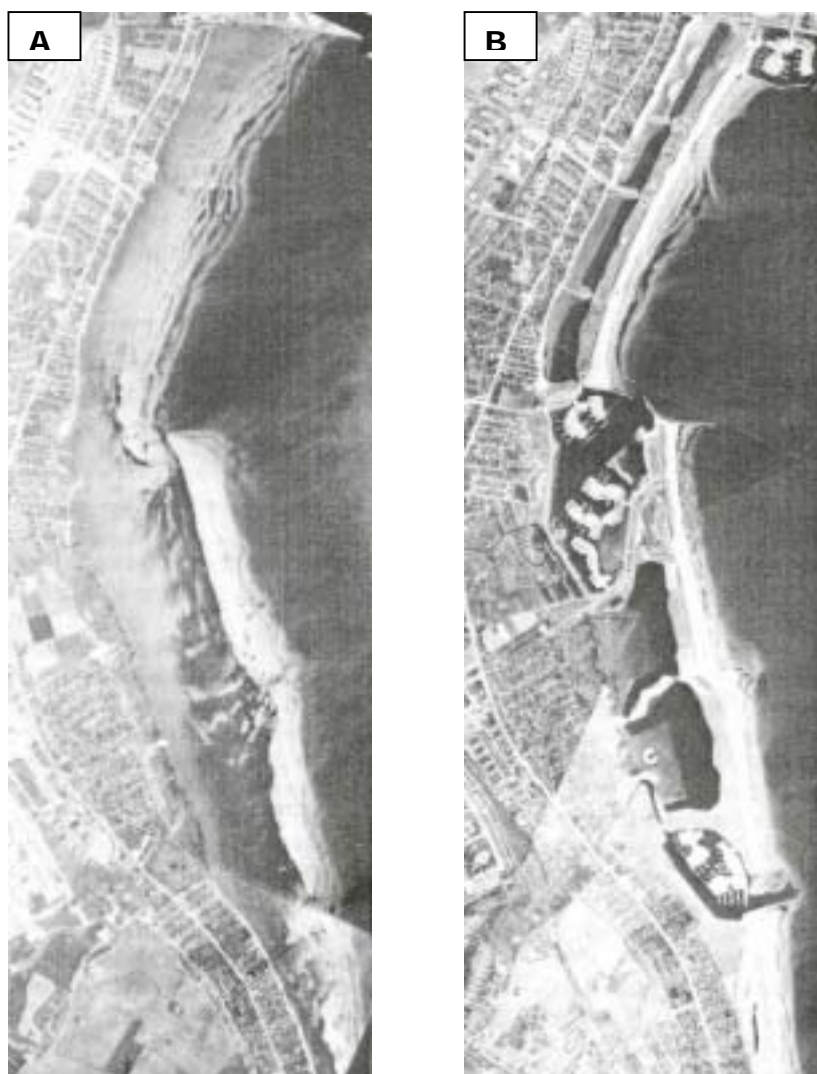
Fig. 3: (Picture 1:) Situation before (A) and after (B) completion of Beach Park.

1. Situation before the Beach Park was built; original coastline.
2. Situation after completion of the Beach Park; coastline has been moved seaward.

These situations are illustrated by the Figures 3A and 3B.

In 1972, the coastal landscape shows a single, sandy ridge- an initial barrier- in the nearshore zone (see Figure 3A). The development of the nearshore zone off the Broendby Strand (north of single ridge) differs markedly and is characterized by multiple and minor bars. Since the 70s the small temporary islands have developed into more permanent barriers.

The park is actually an expansion of natural barrier islands formed in the 20th century in the shallow Bay of Køge (as can be seen in previously shown Figure 3). Between the islands and the coastline shallow lagoon-like areas were formed.

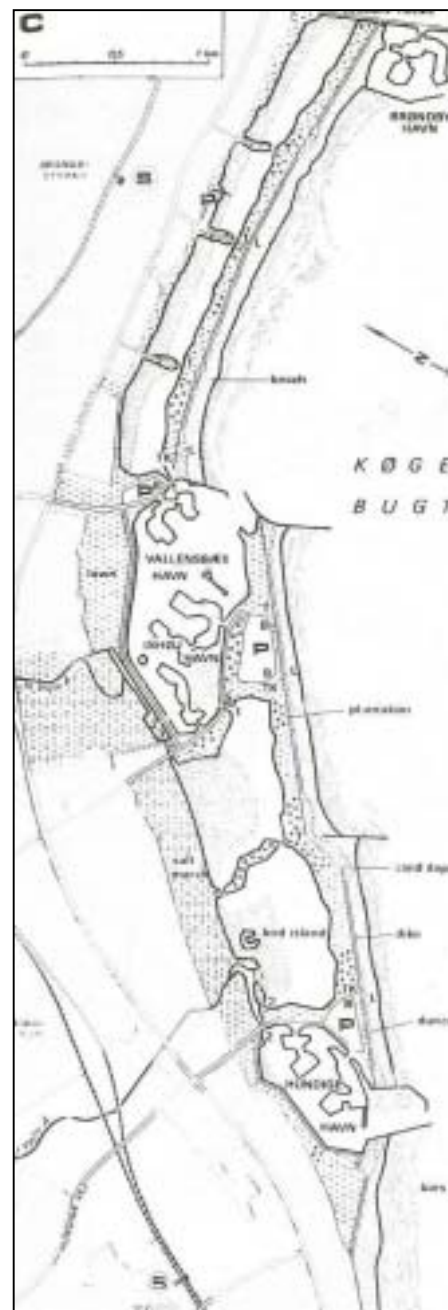
Fig. 5: Land reclamation at Køge Bay.

The backbone of the park is a ca. 7 km long and 300 m wide artificial barrier, built of marine sand, pumped up mainly upon sandy barrier islands. Extensive beach nourishment took place to create the new beaches. The basic idea was to use the sediment taken from the lagoons for this purpose. However, sufficient material was not found in this way. Sample investigation showed that the necessary amount and the right quality could be quarried from the central part of the sea bottom of Køge Bay. To reduce transportation costs, the lagoon areas were extended. In total, 5 million cubic meters of sand were needed for the alteration

of the coastal profile. Of this amount, 3 million was gained from excavation in the lagoon areas and 2 million was dredged from the sea bottom of Køge Bay.

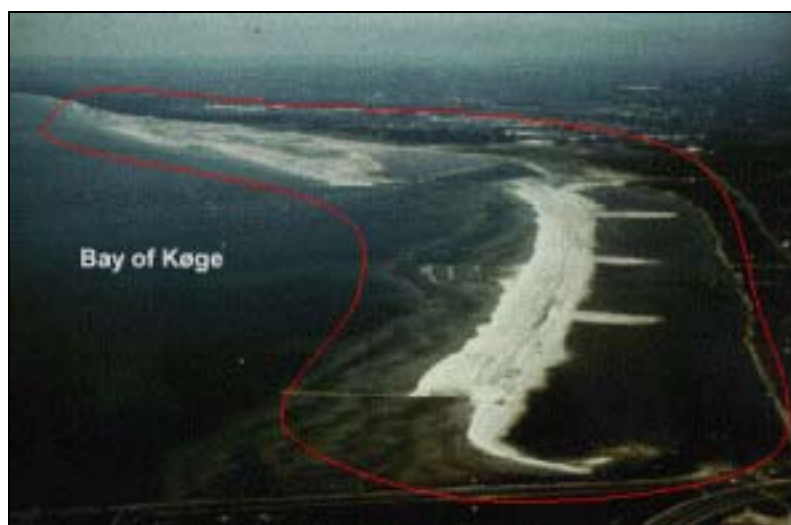
Fig. 7: View of Køge Bay Beach Park, towards the southwest.

Finally, in dike sections where particularly intense traffic was expected, 1-2 m high artificial dunes were created upon the crest of the dike. The dunes provide a buffer of sand and convey some naturalness to the artificial morphology. Also, at the base of groynes and harbour piers, dune-areas were carefully shaped to offer lee-giving points to the benefit of the bathing guests. Besides the scenic values of the coastal landscape, these dunes are meant for emergency sand depots in case the sea threatens the dike system.

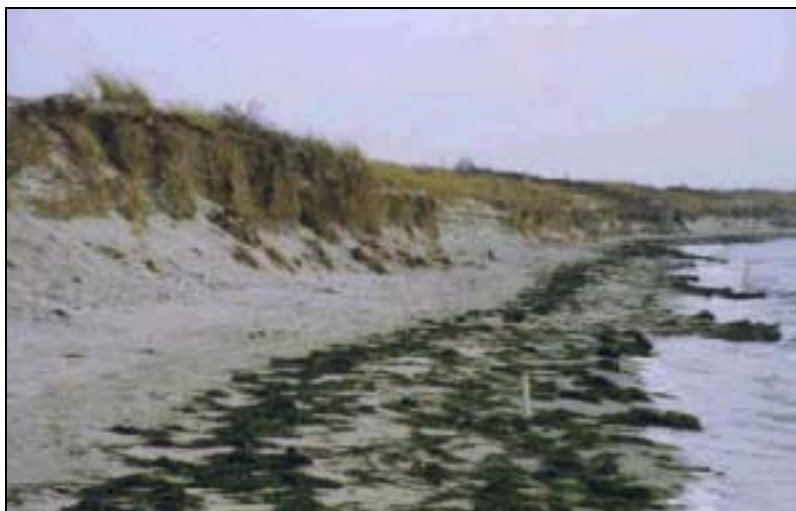
Fig. 8: Lee-side erosion and filter tube system at Køge Bay.

A septic attitude towards the effect of the installed filter tube system to combat the leeside erosion is stated. It could not be proved that they contribute to an increased sedimentation. German delegates doubt the effectiveness of the system, because a draining effect normally can only be seen 0.5 to 1.5 m around tubes of this size. Furthermore, the tidal range of 0.1 m at this location is considered to be much too low to cause a considerable effect.

The filter tubes consist of ca. 2 m long vertical tubes, which are perforated at their lower part. At the Strandparken beach they are installed in 5 profiles with two tubes each and a distance of 70 m between the profiles.
