WESTERN COAST OF POLAND (POLAND)

1. GENERAL DESCRIPTION OF THE AREA

WP 4.1 D.3. Report of UAB Pilot Sites EUROSION – Draft v.3 (February/2003)

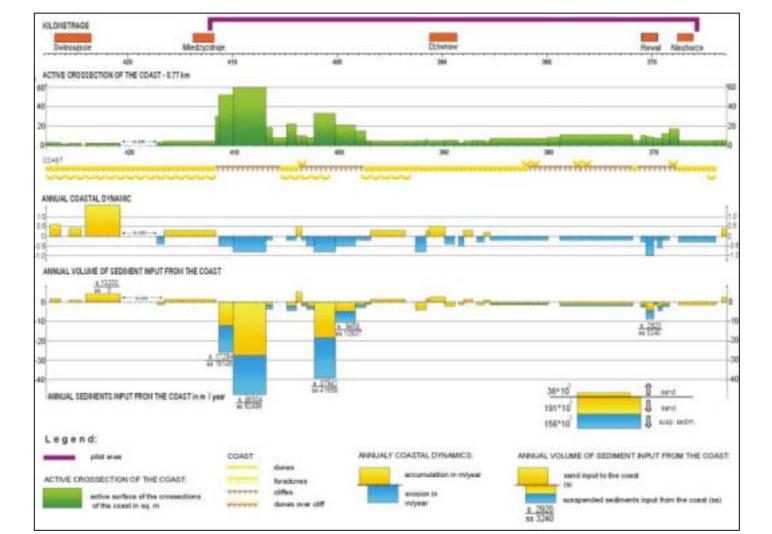
Fig. 9: Sedimentary budget of the coast.

The magnitude of sediment input depends on the geological structure of the coast (see Figure 9). It was calculated that from the cliff erosion $191 \cdot 10^3$ m3/yr of sand come to the coastal zone. About $36 \cdot 10^3$ m³/yr of this sediment is used in accumulation processes. Additionally, $156 \cdot 10^3$ m³/yr of eroded sediments come to the deeper part of the basin in suspended form. Both moraine cliffs and sandy dunes are vulnerable to water and wind erosion. The rate at which erosion takes place varies from one area to the other (from 0.2m/yr to 1.0m/yr).

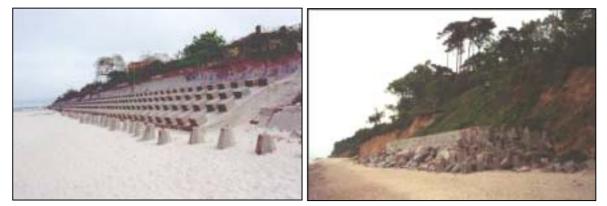
Fig.15: Seawall in Dziwnow.

- Medium seawall: Remnants of this type of wall is found in Dziwnow and Wolin National Park.
- Hard seawall: This method of construction has been used in different places at different times and for various purposes. In Niechorze this measure was performed in 1900 in order to reinforce the lighthouse. In Dziwnow this construction was done in order to protect the buildings which are located on the very narrow Dziwnow Split. In Trzesacz this type of wall is constructed order to protect the remaining wall of a historical church which was constructed in the 15th century. The church is constructed at 2.5km from the sea.
